IOR/EOR FIELD TEST RESULTS

HYPERSCRATCHER

Borehole Cleanout Tool

Enhanced Oil Recovery Institute

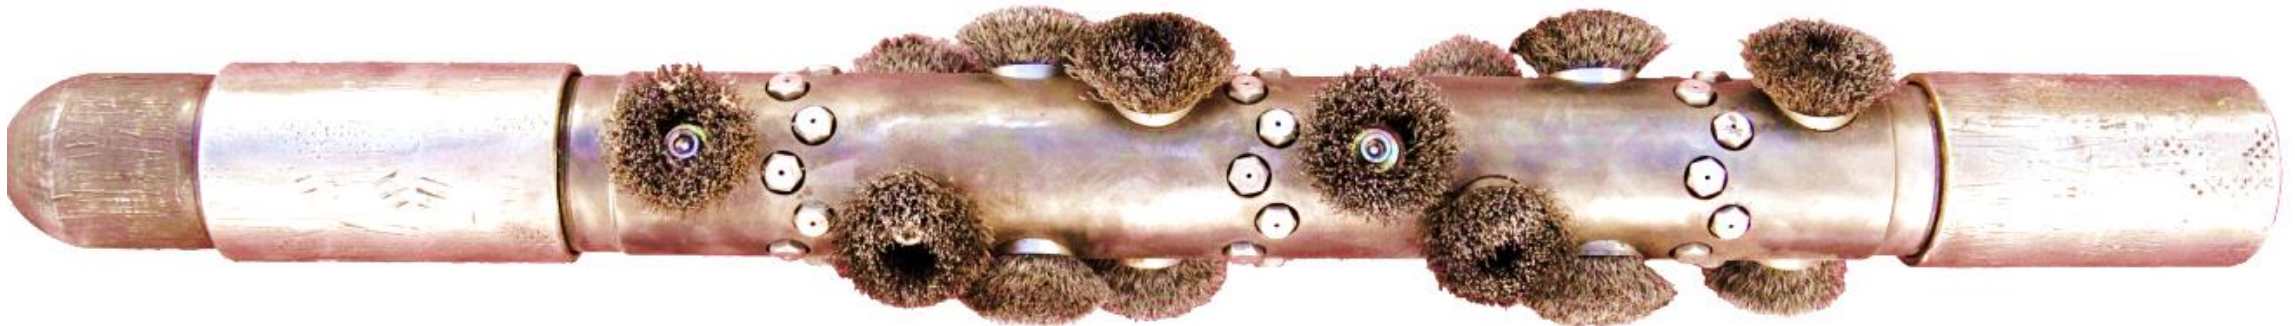
Hyperscratcher Tool

- The Hyperscratcher tool was initially designed and used in California in the 1980s for workovers; as yet it has not been widely used in Wyoming
- Multiple cleaning methods in one tool
 - Jets direct water, acid, or other chemicals directly to targeted areas
 - Wire brushes physically clean the surface of casing, perforated liners, etc.

- The Hyperscratcher tool is conveyed via tubing or coiled tubing unit (CTU)
- Tool is normally lowered to a few feet below the lowermost perforations or zone of interest
- Pump is engaged to inject water or desired chemicals through tool jets; tool is reciprocated 2 to 3 times slowly while scrubbing back and forth across the perforated/slotted interval while pumping fluid at a rate of 1 to 3 bpm
- Repeat treatment across all targeted areas
- Wire brushes can be replaced as needed

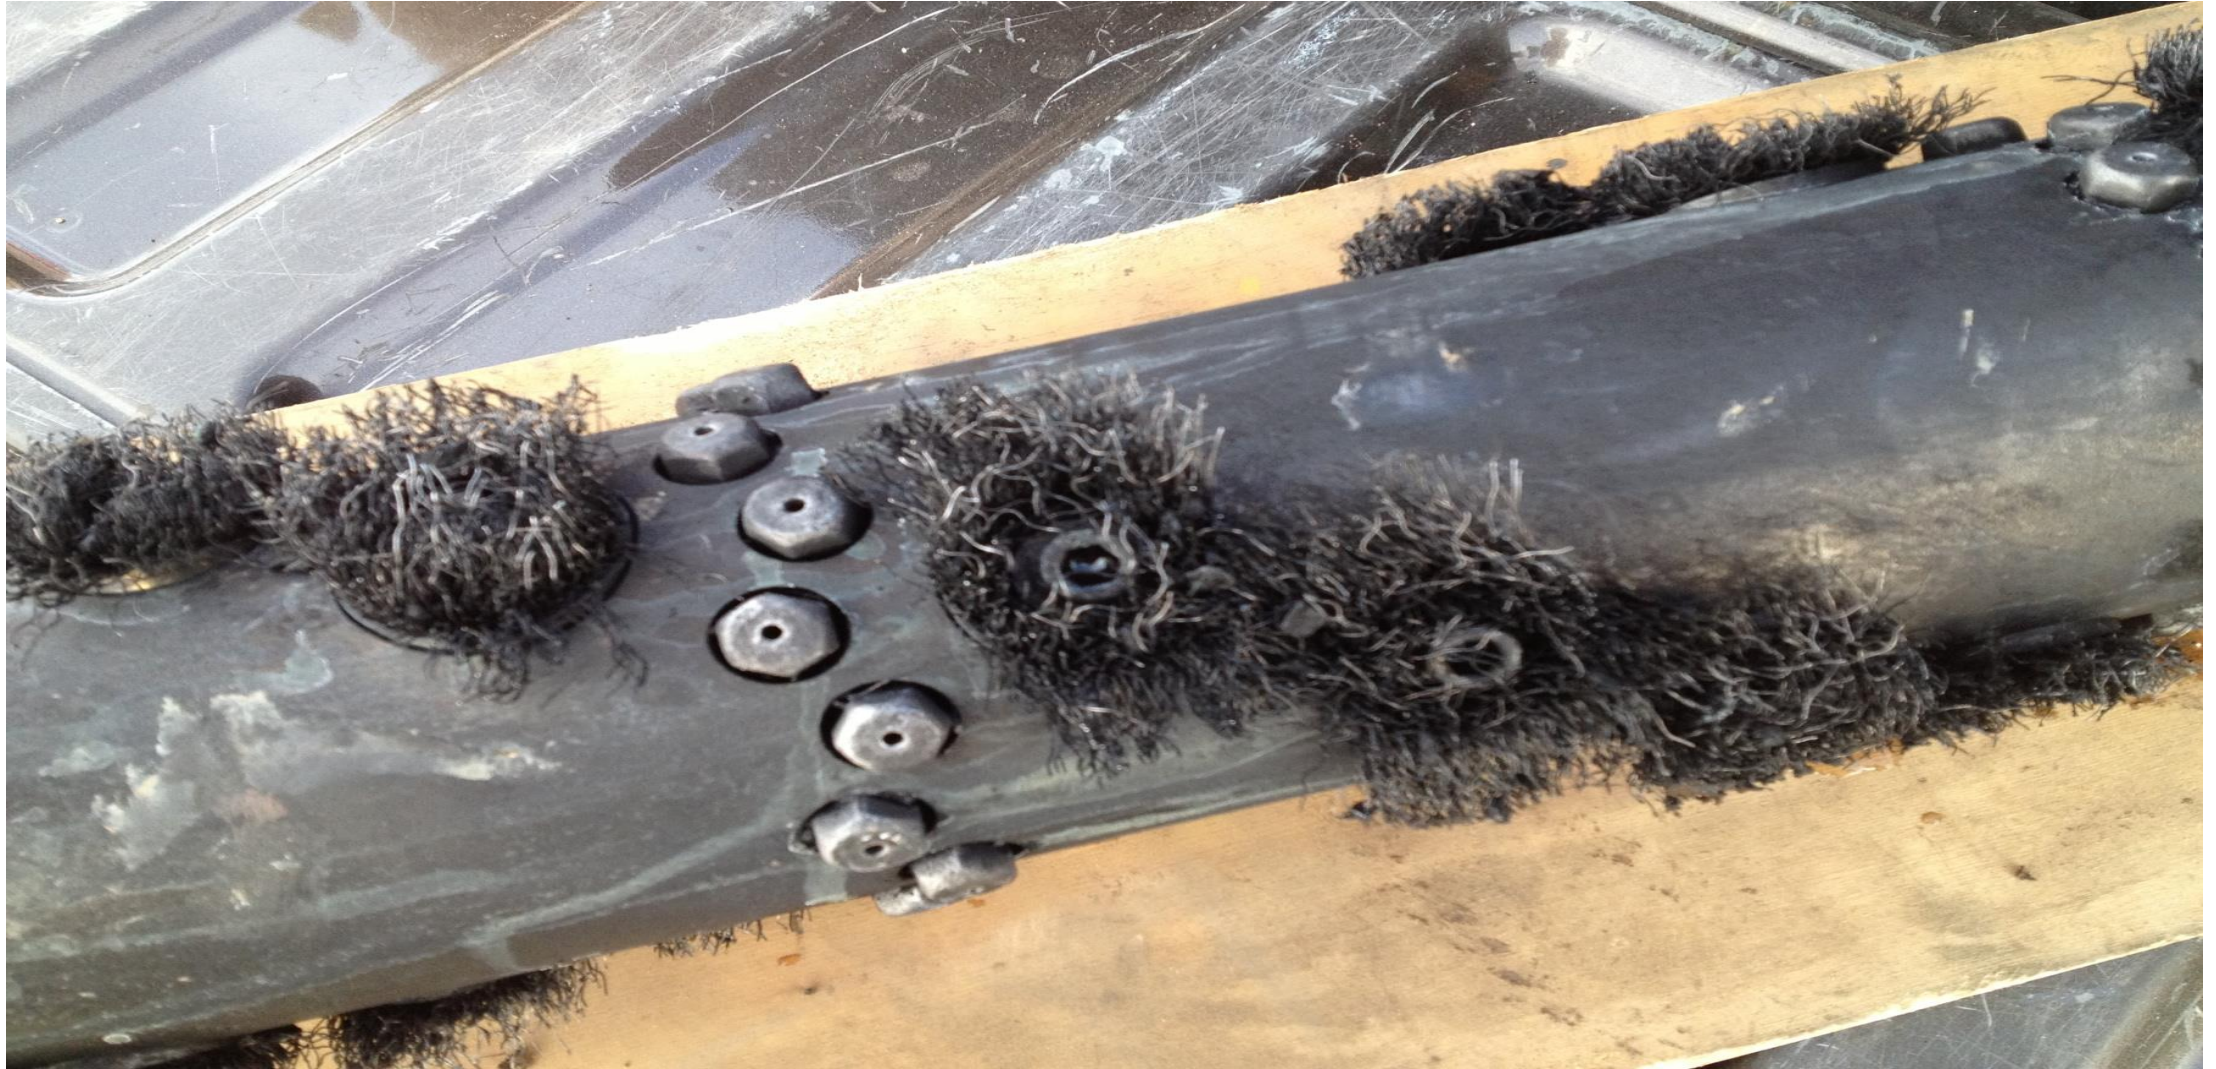
Condition of replaceable wire brushes after a well cleanout

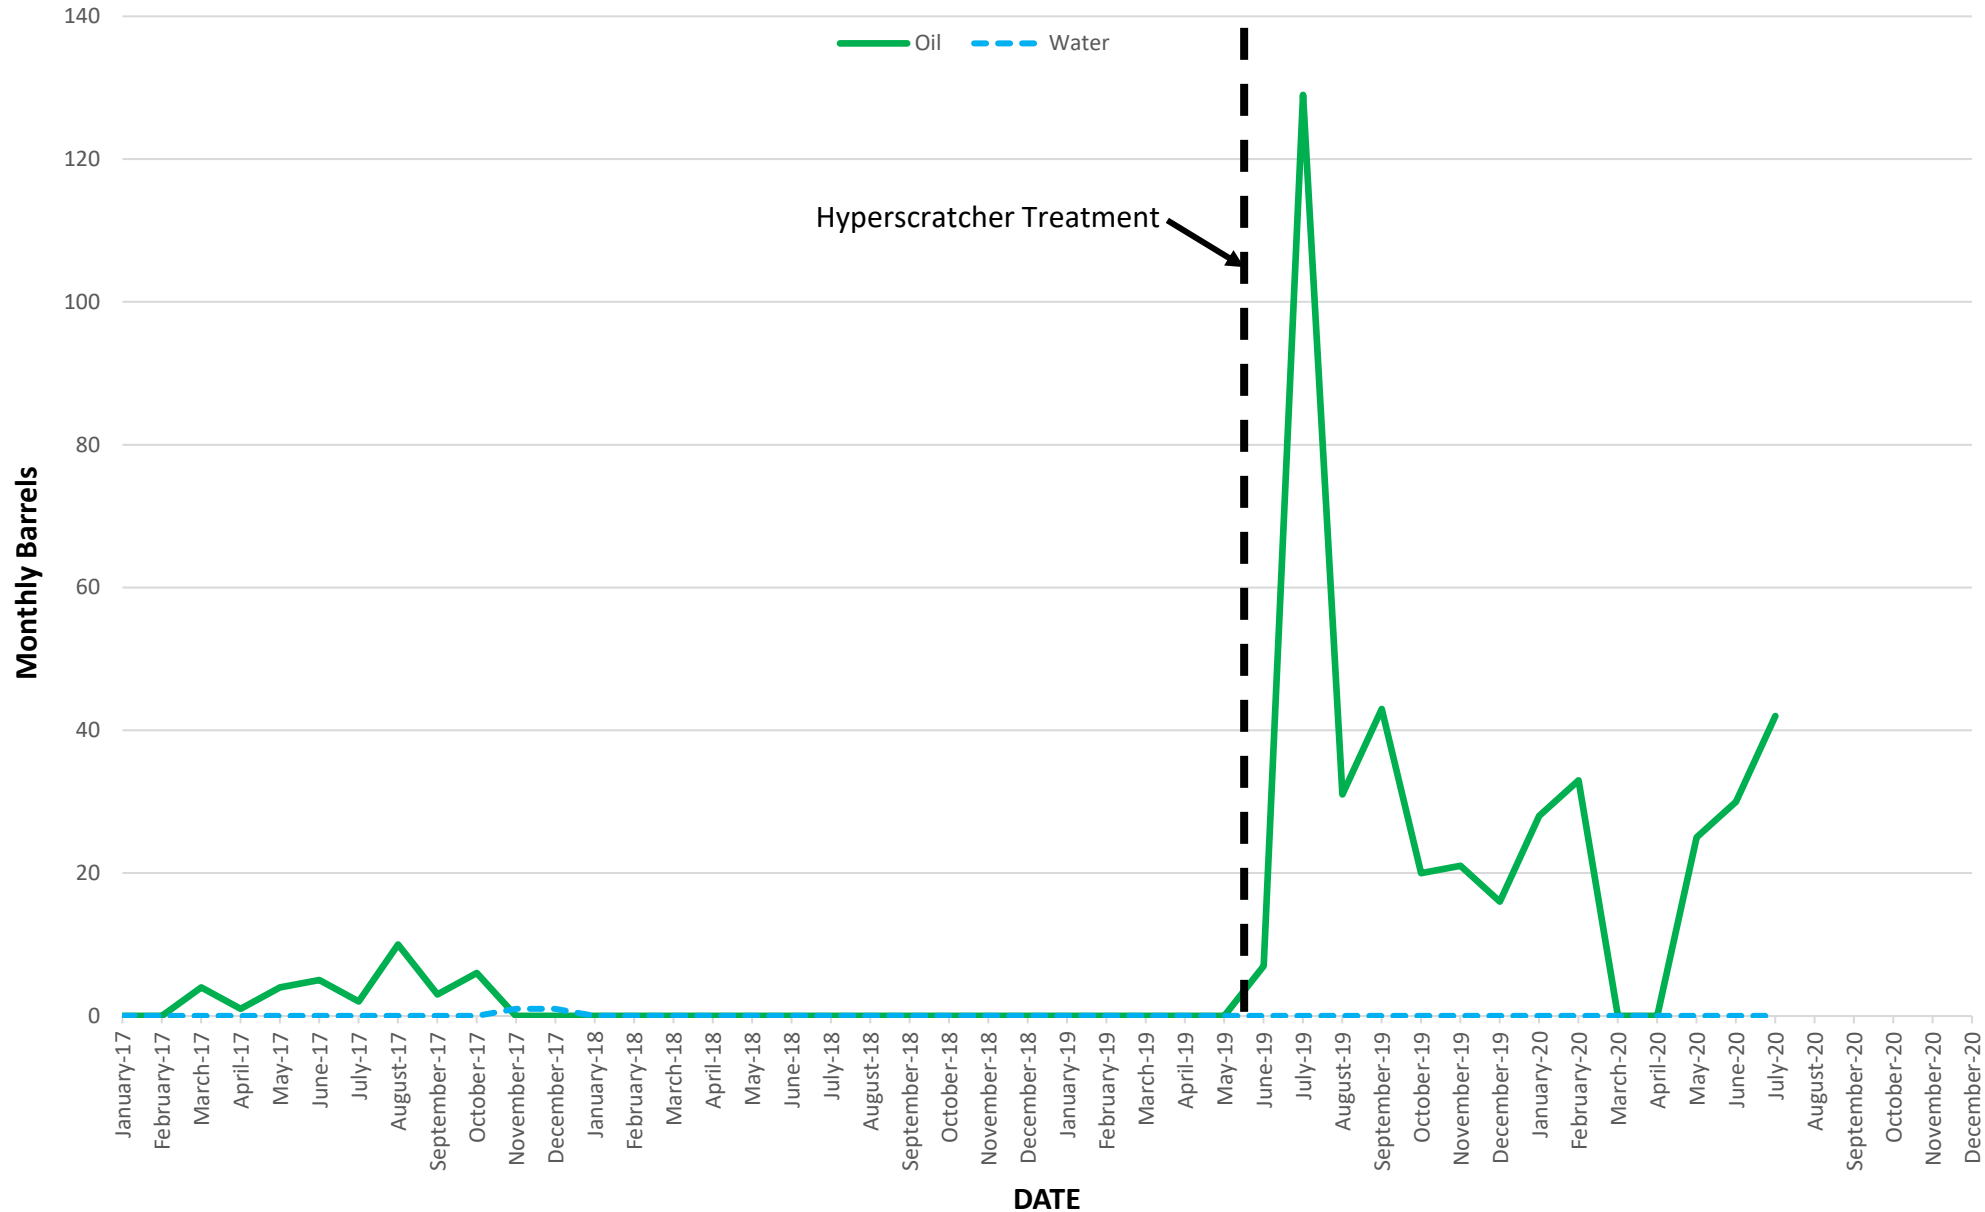
JJ Bunkirt Federal 23-1: Monthly Production

JJ Bunkirt Federal 23-1 (monthly)

- Problem: Paraffin
- Treatment: 5/20/19
- Significant improvement in production after treatment

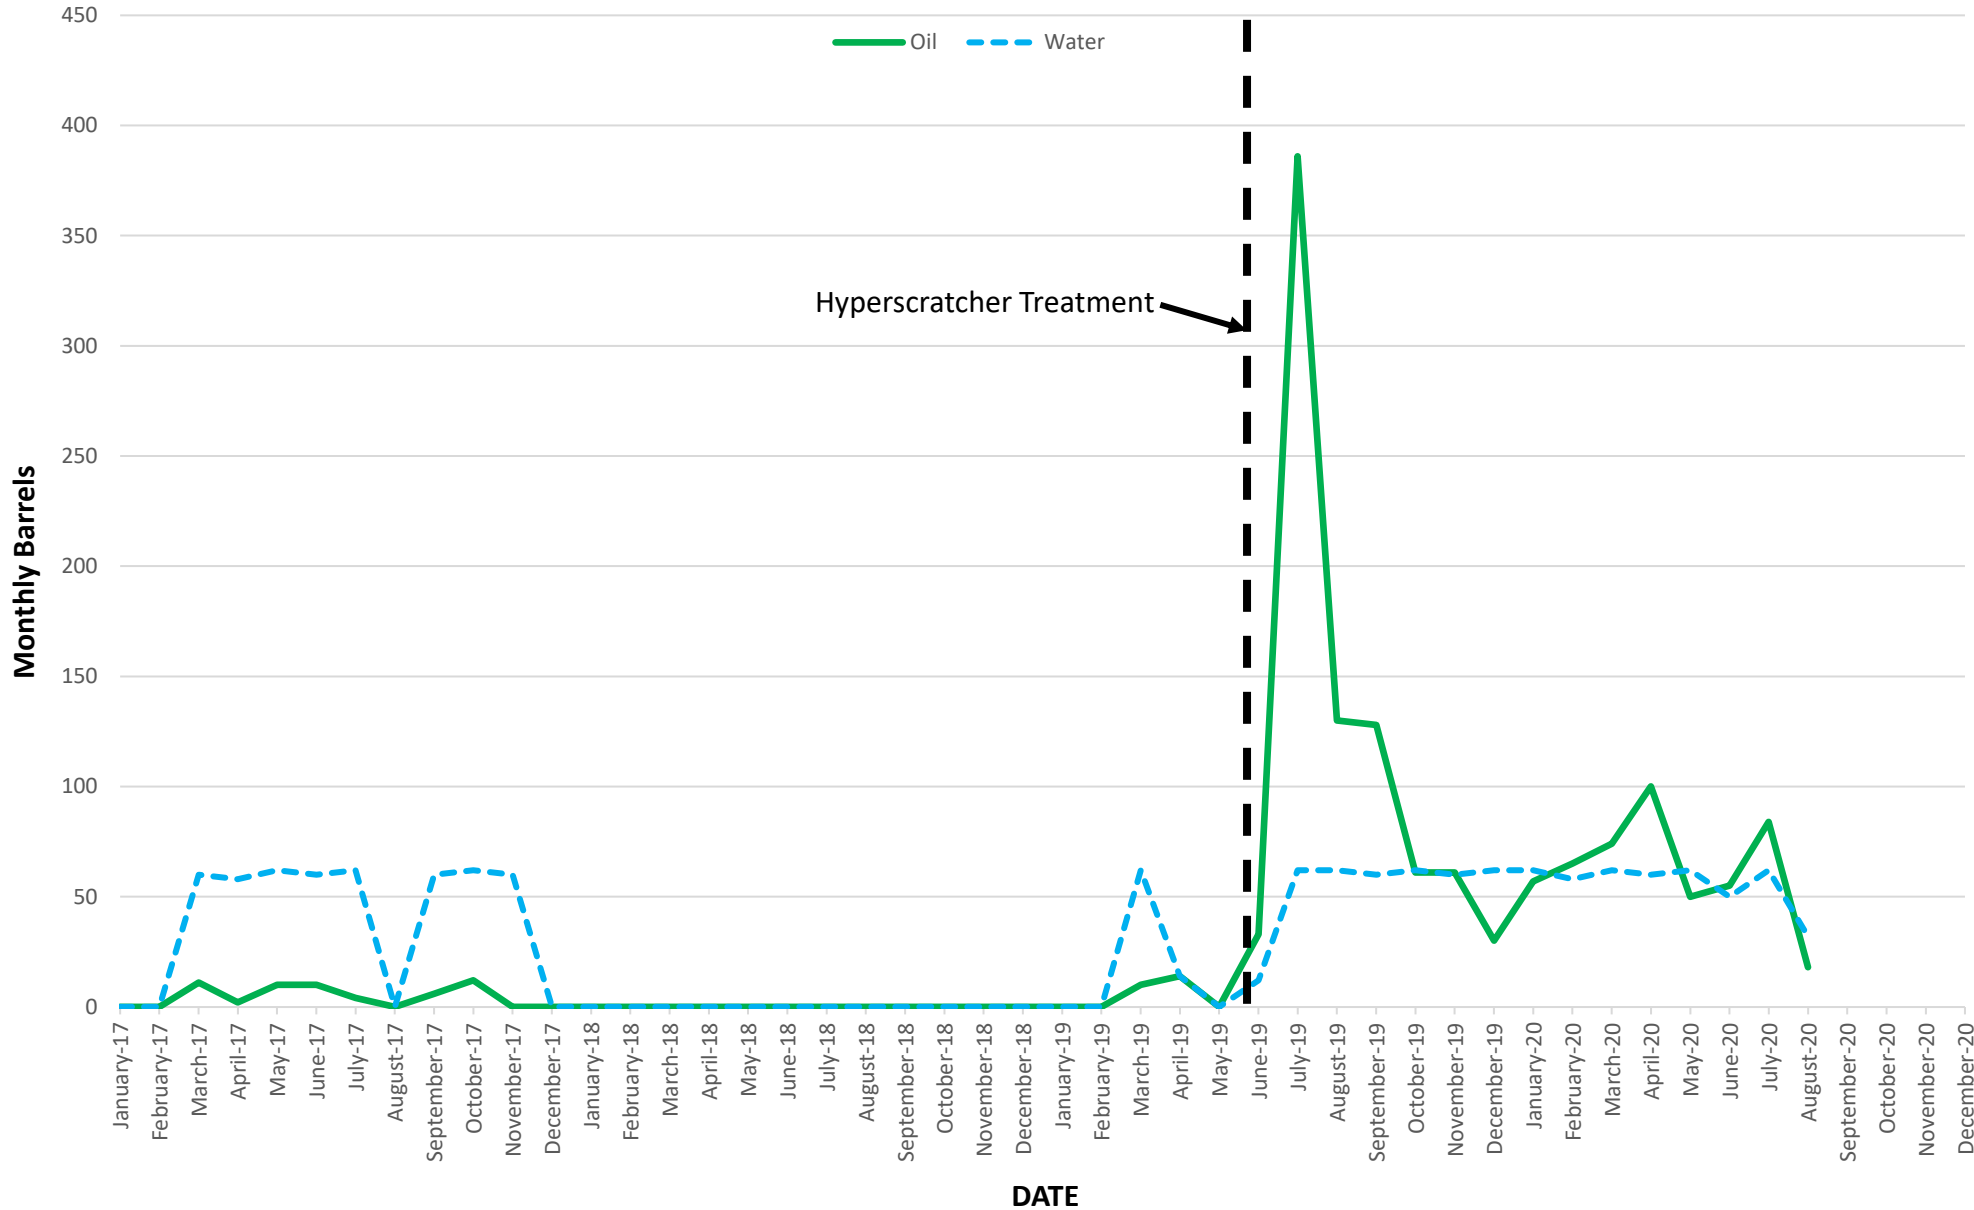
JJ Bunkirt J. E. Pepper #3: Monthly Production

JJ Bunkirt J.E. Pepper 3 (monthly)

- Problem: Paraffin
- Treatment: 6/12/19
- Significant improvement in production after treatment

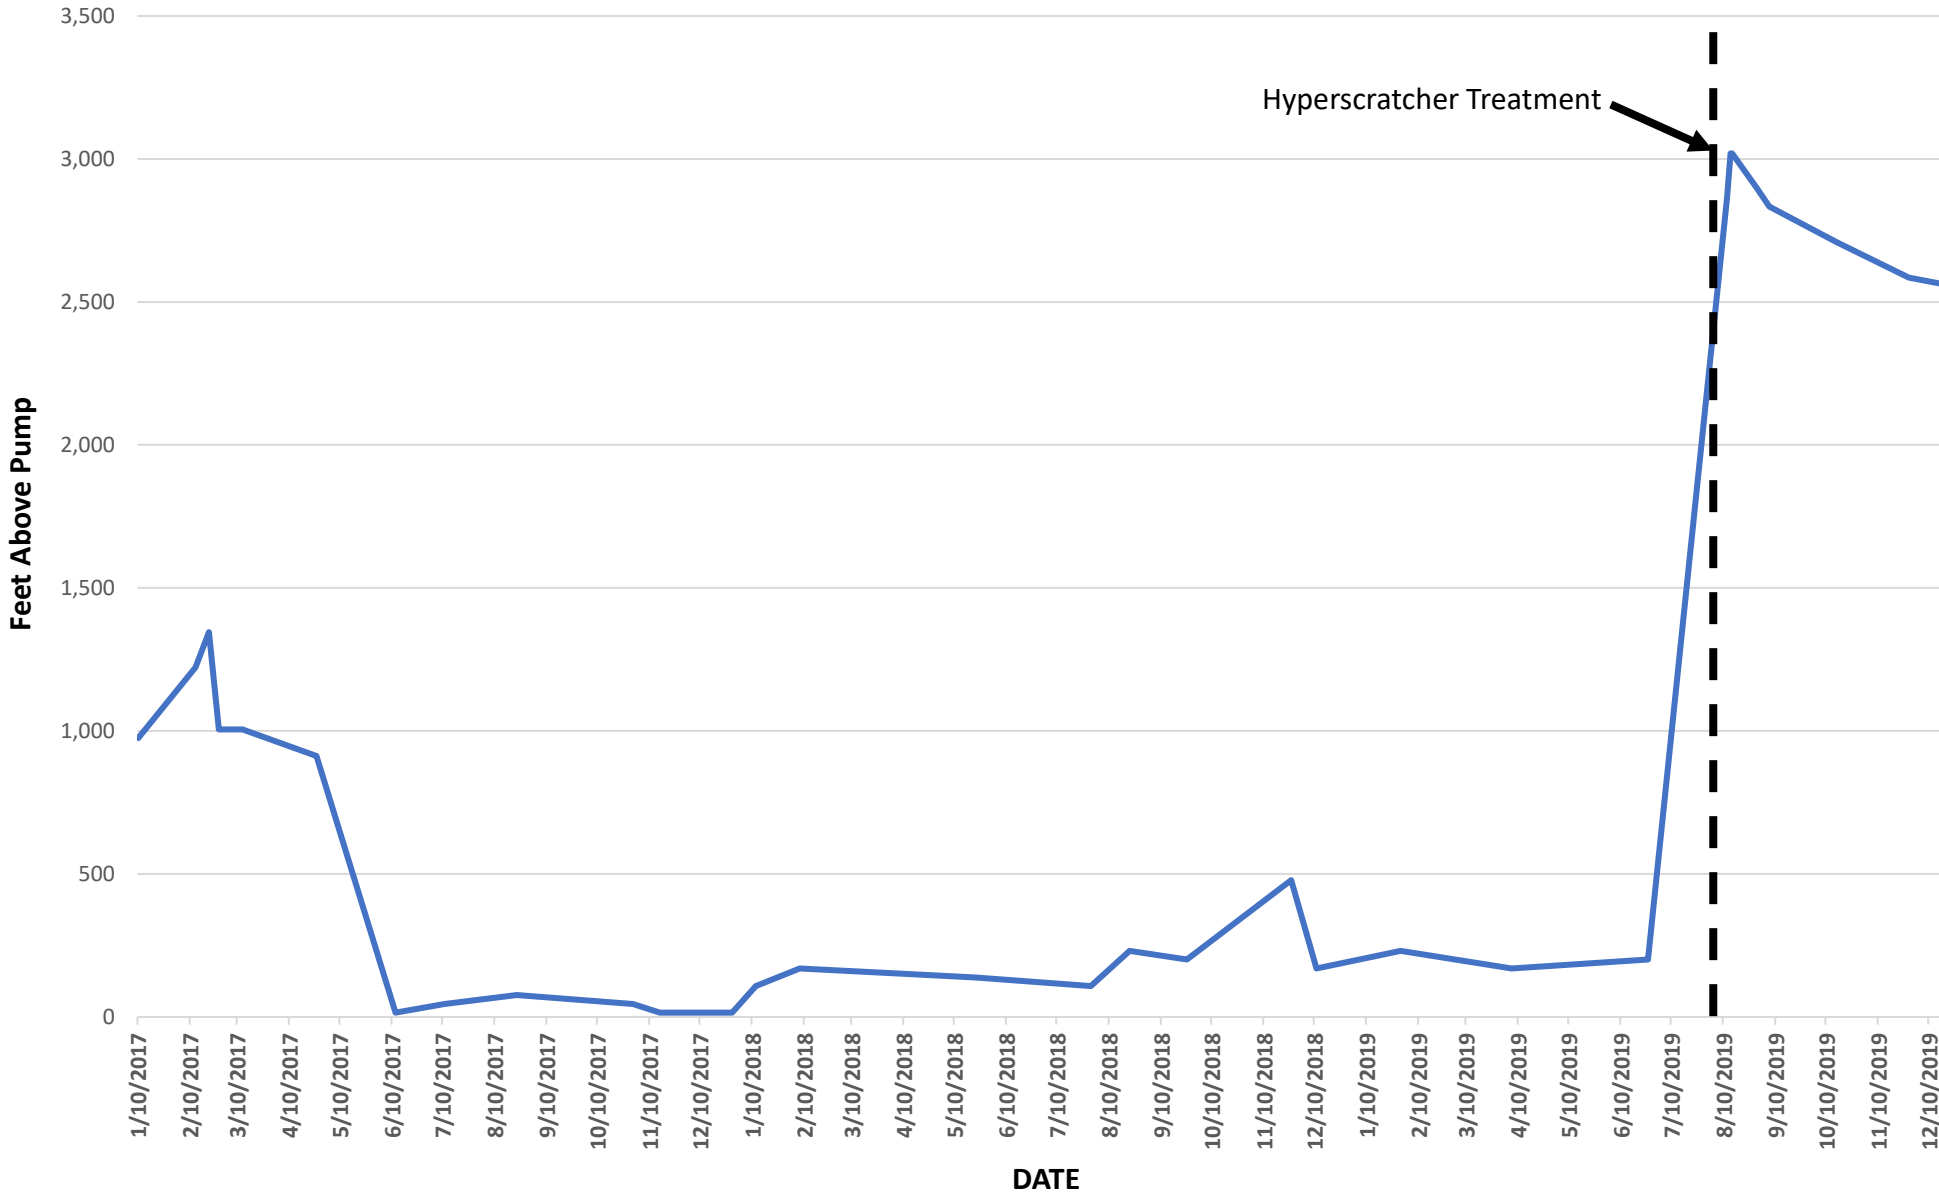
Breitburn Gebo #69: Fluid Level in Borehole Above Pump

Breitburn Gebo #69 Fluid Level Feet Above Pump

- Problem: Scale & Paraffin
- Treatment: 8/8/19
- Fluid level measurements show significant increase in fluid flow into borehole after treatment
 - 4 months prior to treatment the avg fluid level was 185.5 feet above the pump
 - 4 months after treatment the avg fluid level was 2,810 feet above the pump
- No oil production data were submitted by the operator

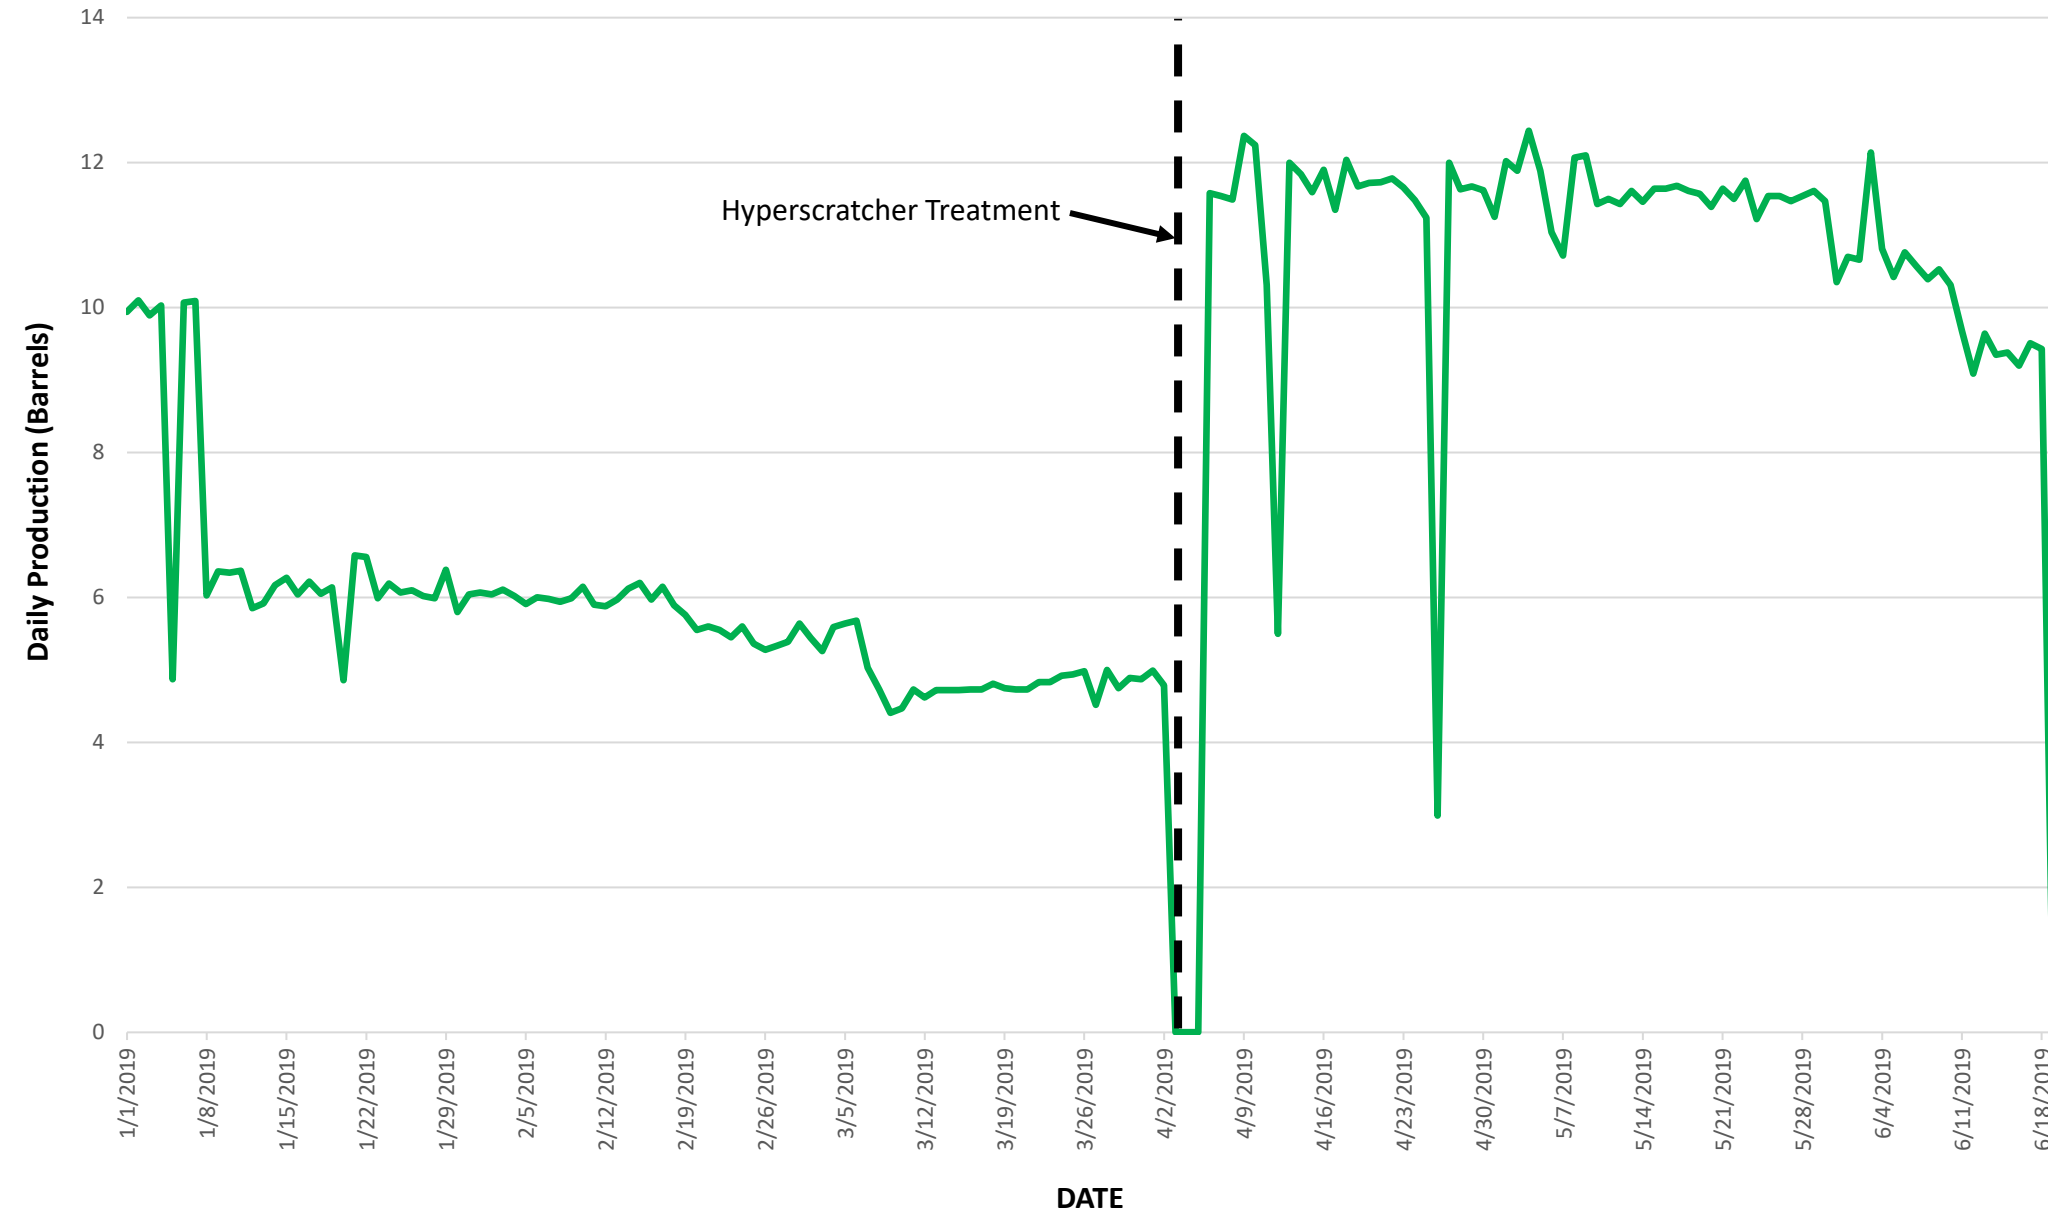
Breitburn Gebo #2: Allocated Daily Oil Production

Breitburn Gebo #2 (daily)

- Problem: Scale & Paraffin
- Treatment: 4/3/19
- Significant improvement in oil production after treatment
 - Prior to treatment, 60-day average production = 5.3 BOPD
 - After treatment, 60-day average production = 11.7 BOPD
 - ~120% improvement

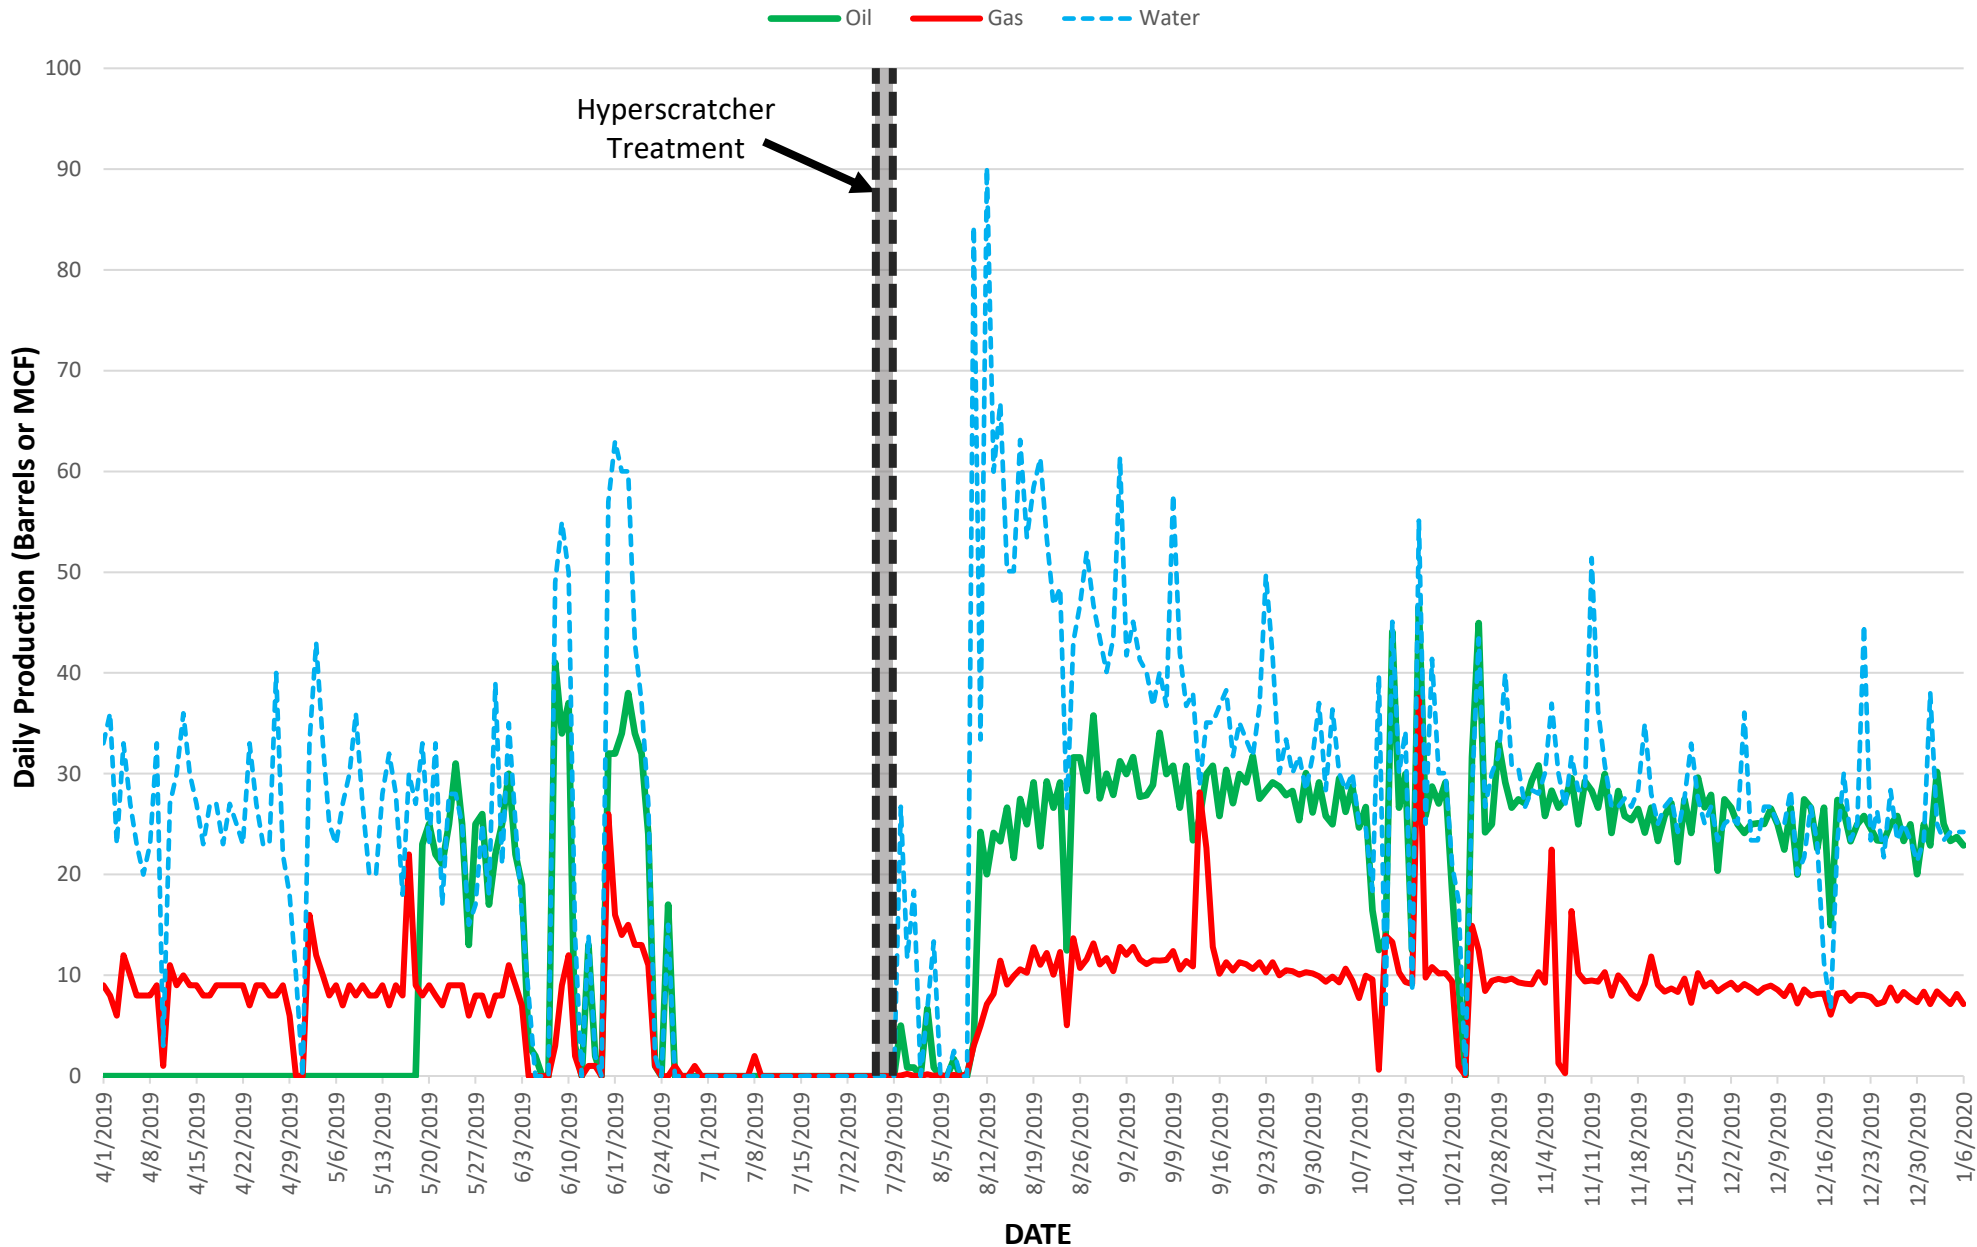
Company A "A-1 Horizontal": Daily Production

- Problem: Paraffin & Scale
- Treatment: 7/26-29/2019
 - Pumped 17 bbls of acid through tool
 - Flushed with 34 bbls water
 - Cleaned perfs with tool; jetted 20 bbls water/perf set
- Delay in full production after treatment due to disposing of water from location
- Production increased and was relatively steady after treatment

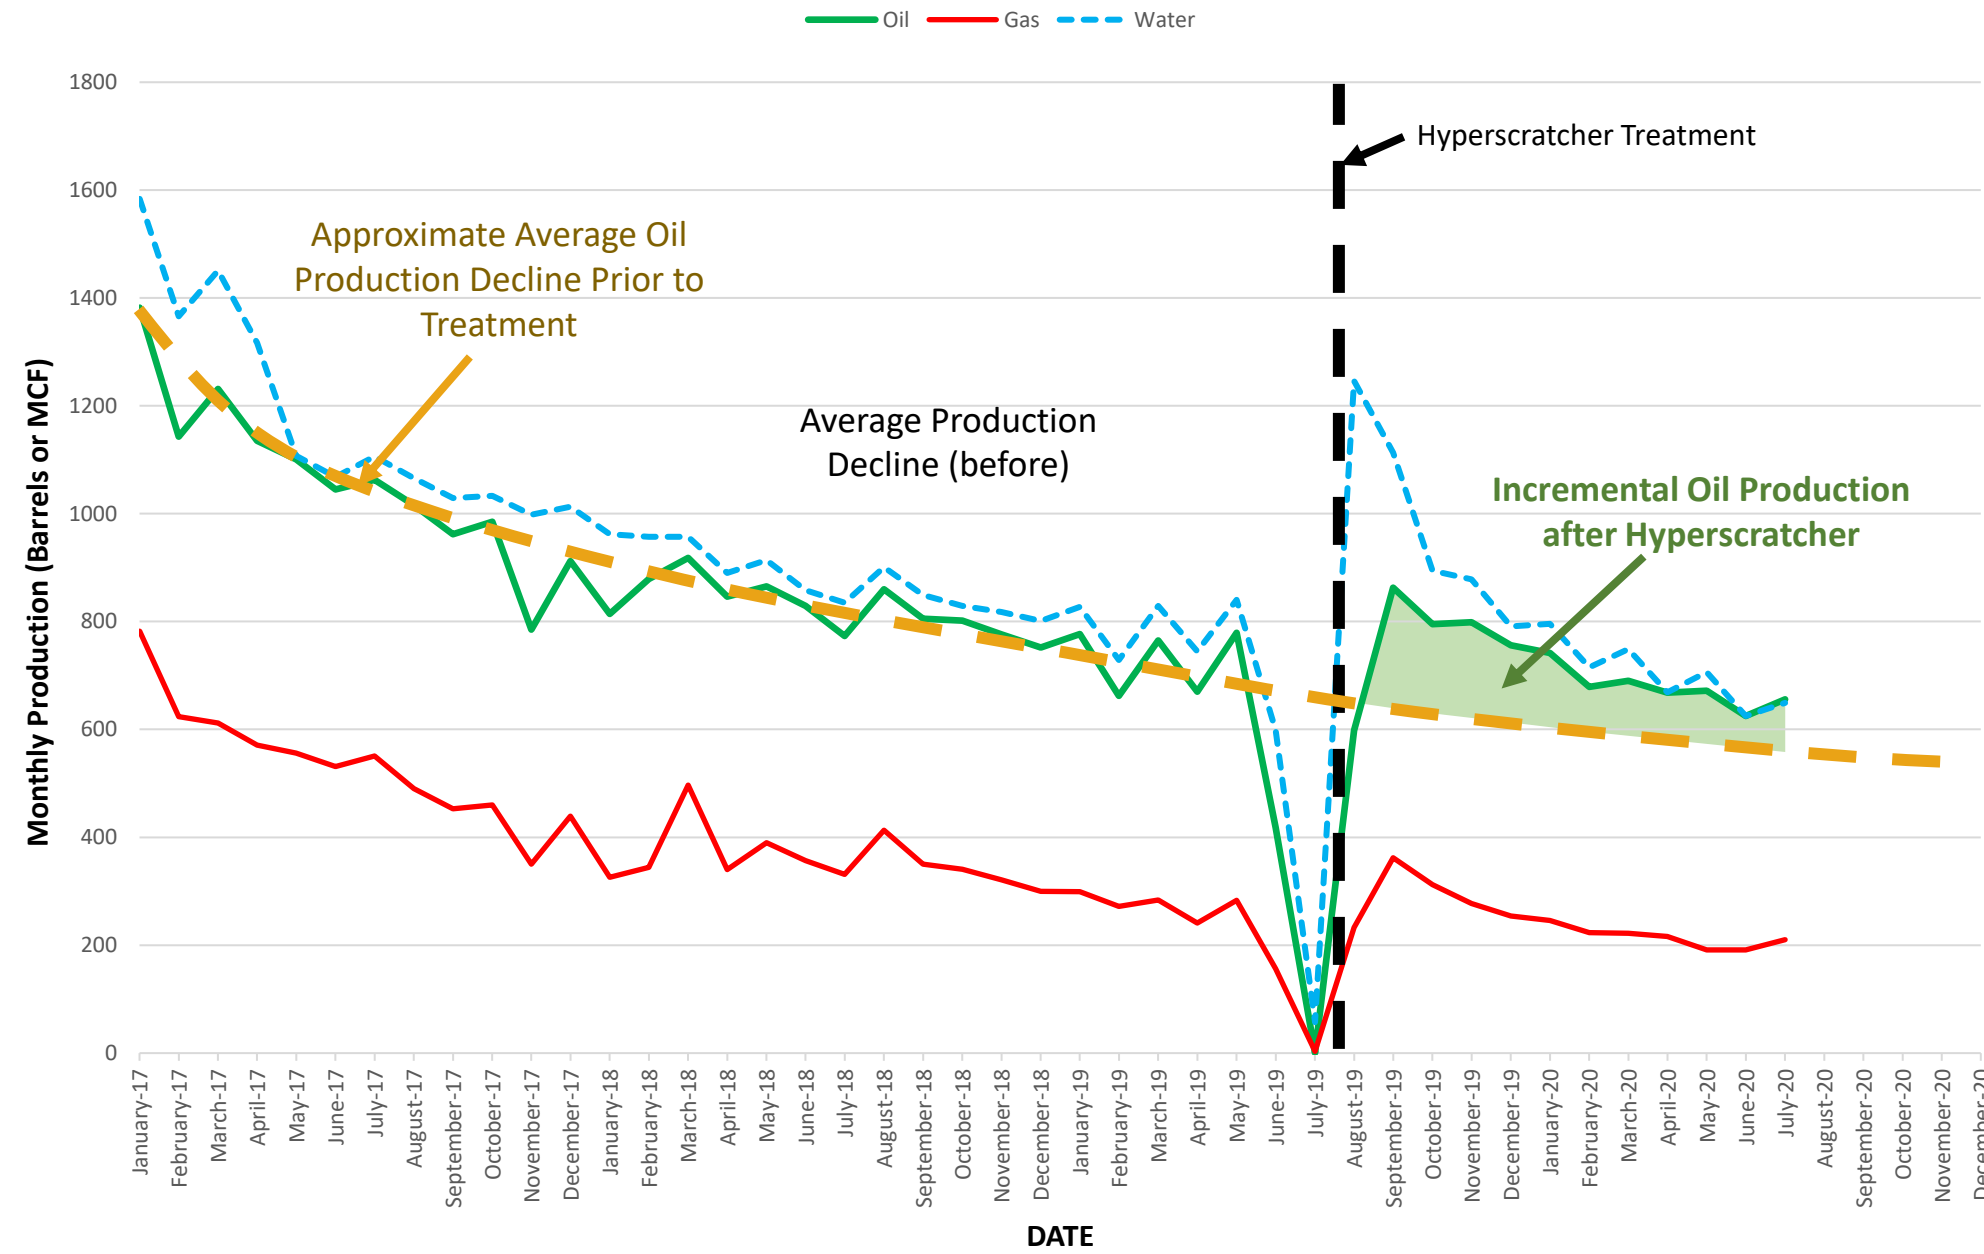
Company A "A-1 Horizontal": Monthly Production

- Problem: Paraffin & Scale
- Treatment: 7/26-29/2019
- Production improved after treatment
- Incremental oil production from 9/2019-7/2020 is ~1,480 BO
- ~23% improvement over projected pre-treatment production rate

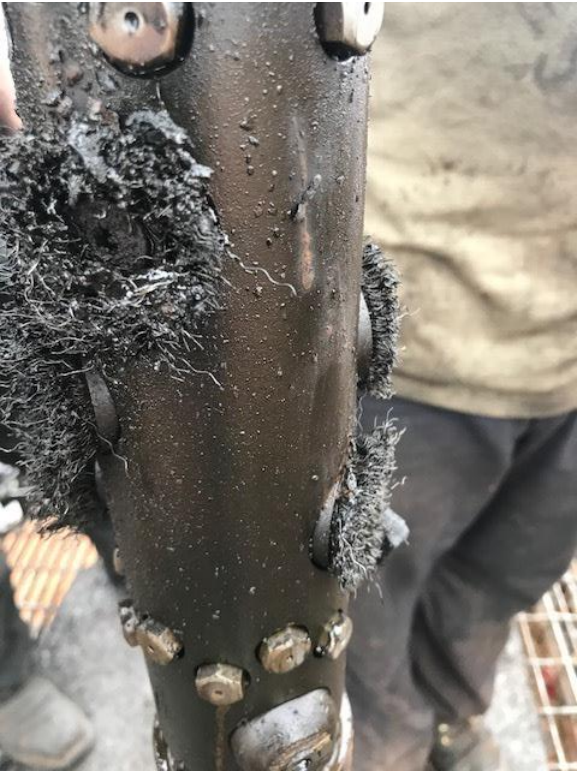
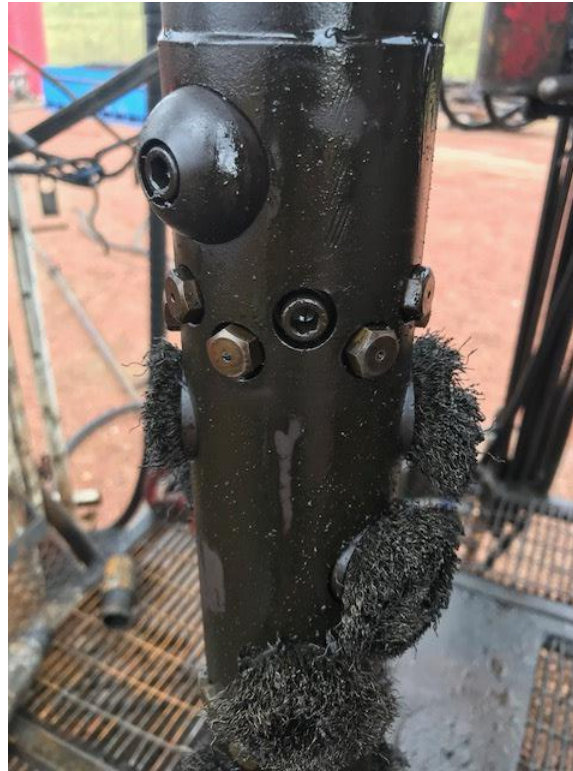
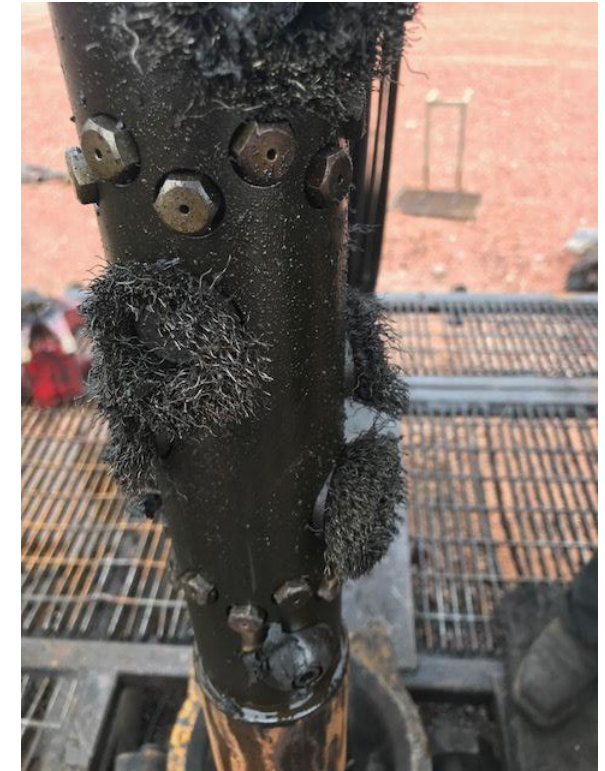
Company A “A-1 Horizontal”: Tool Condition After Run

These photos show the condition of the replaceable wire brushes after a run in the “A-1 Horizontal”. This was the longest of the three horizontal wells in which the tool was used (approximately 4,200’ lateral). Multiple perforated intervals in the lateral required use of the tool over 3 days.

It is common for the brushes to be well worn after a treatment. They are replaced before the next use of the tool.

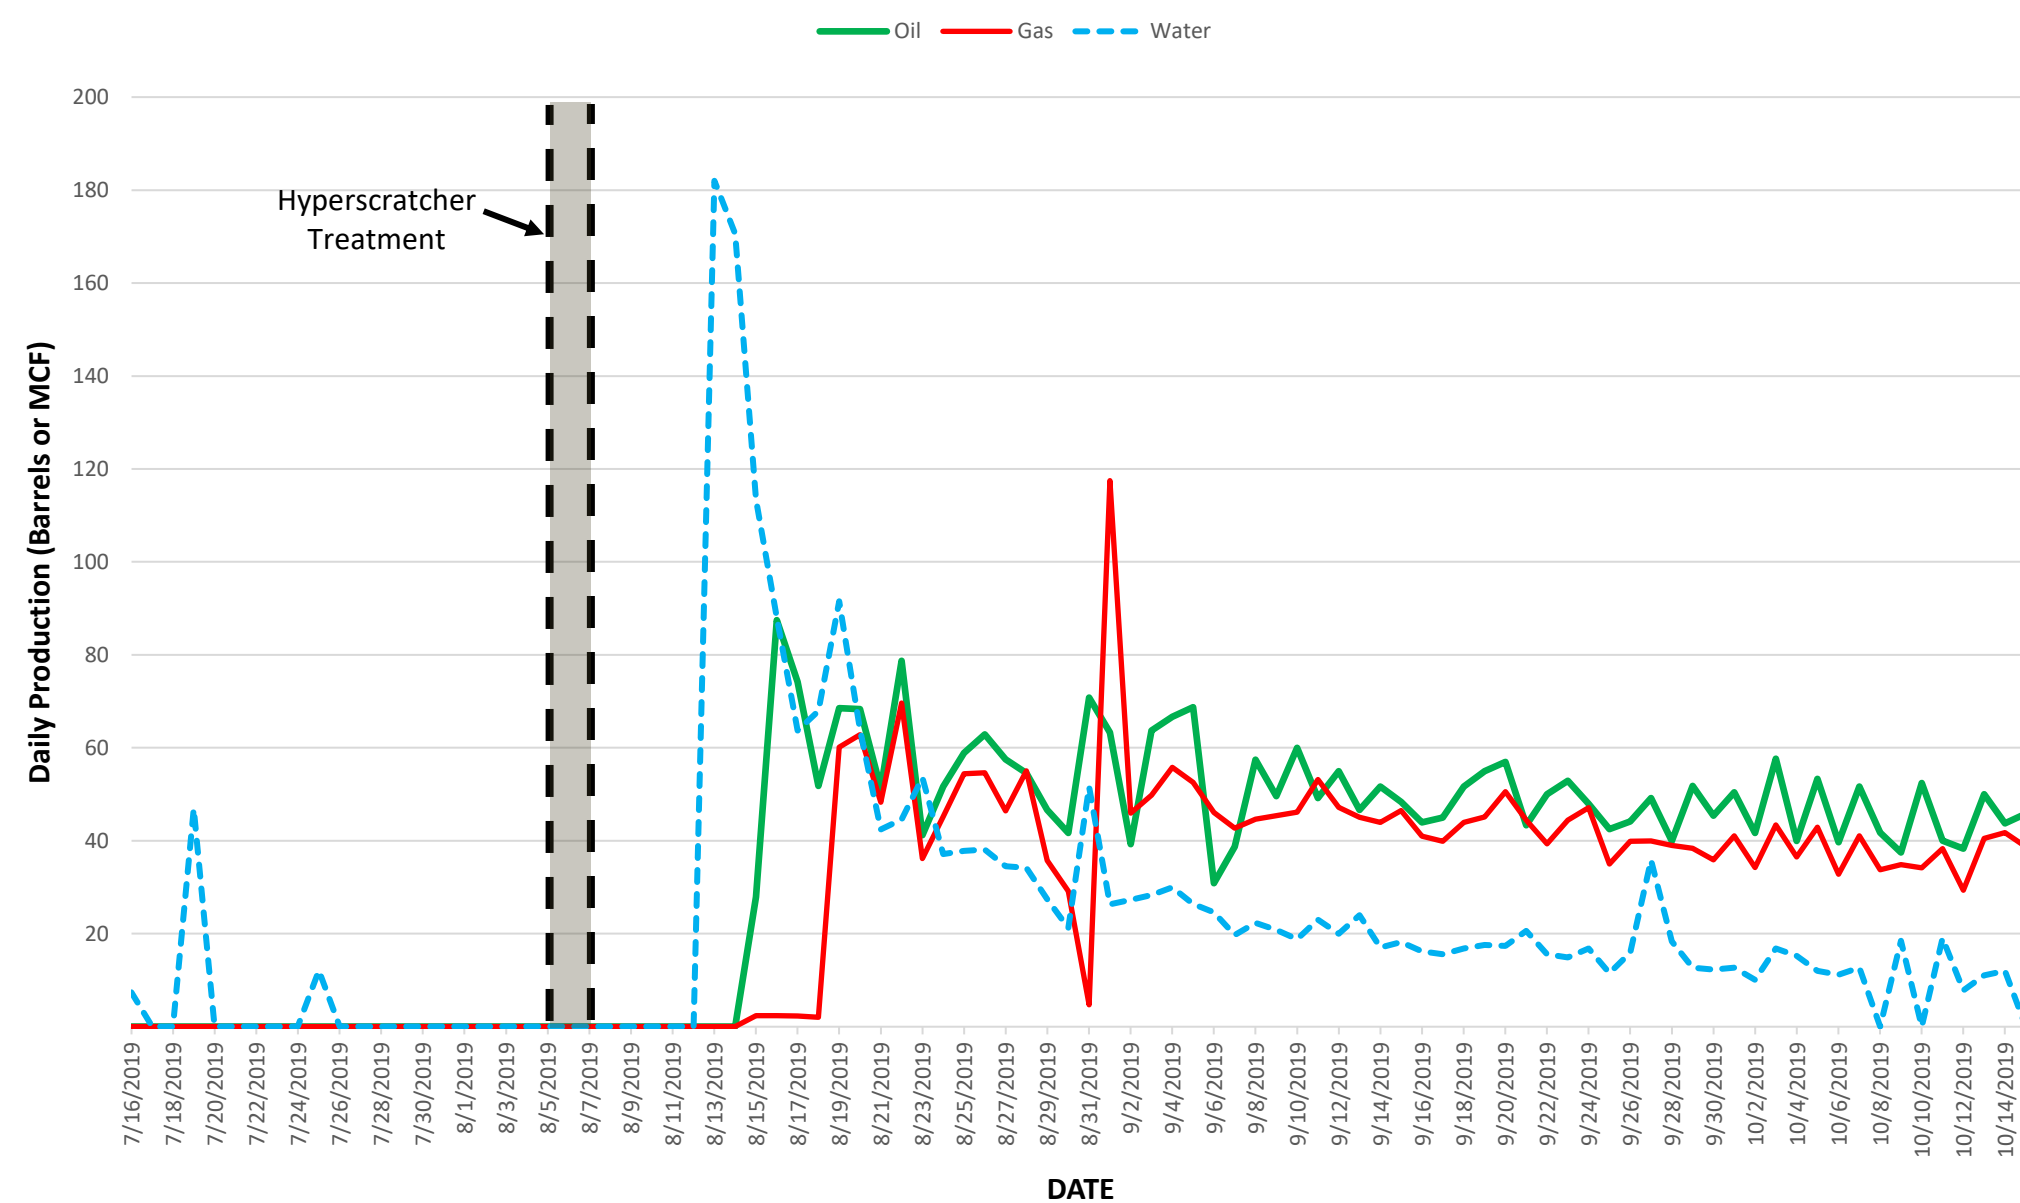
Company A "A-2 Horizontal": Daily Production

- Problem: Paraffin & Scale
- Treatment: 8/5-7/2019
 - 30 bbls water & acid injected at each perf set
- Delay in full production after treatment due to testing & disposing of water from location
- Production improved after treatment
- Immediate and temporary increase in water production due to volume of water used in treatment (stated by operator)
