IOR/EOR FIELD TEST RESULTS

HYPERSCRATCHER

Borehole Cleanout Tool

Enhanced Oil Recovery Institute

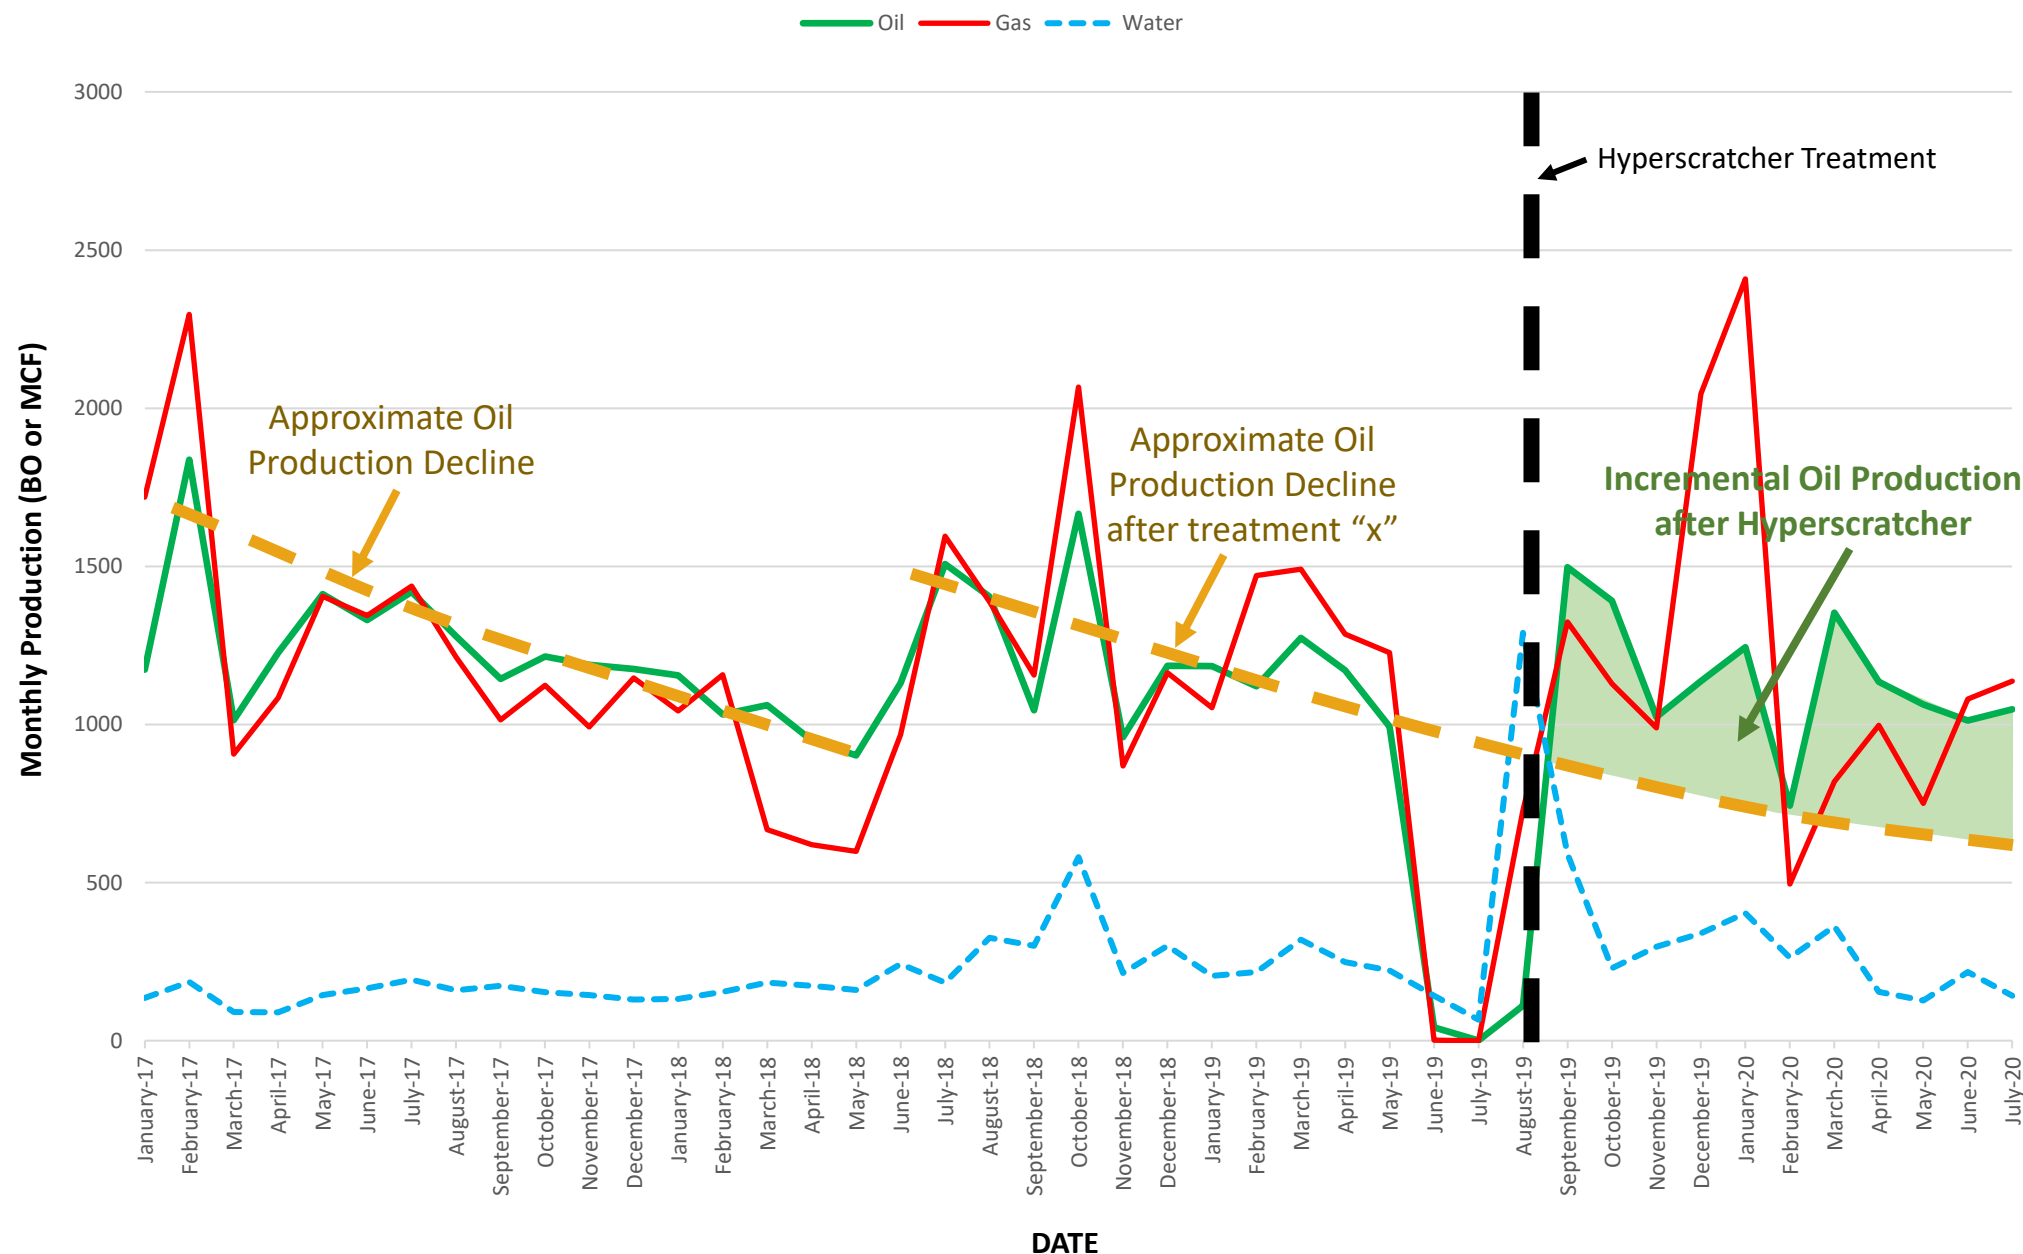
Company A "A-2 Horizontal": Monthly Production

- Problem: Paraffin & Scale
- Production improved after treatment
- Average decline rate after Hyperscratcher treatment similar to a different treatment a year prior
- Estimated incremental production from 9/2019 to 7/2020 is ~5,100 BO
- Approximately 67% improvement over projected pre-treatment production rate

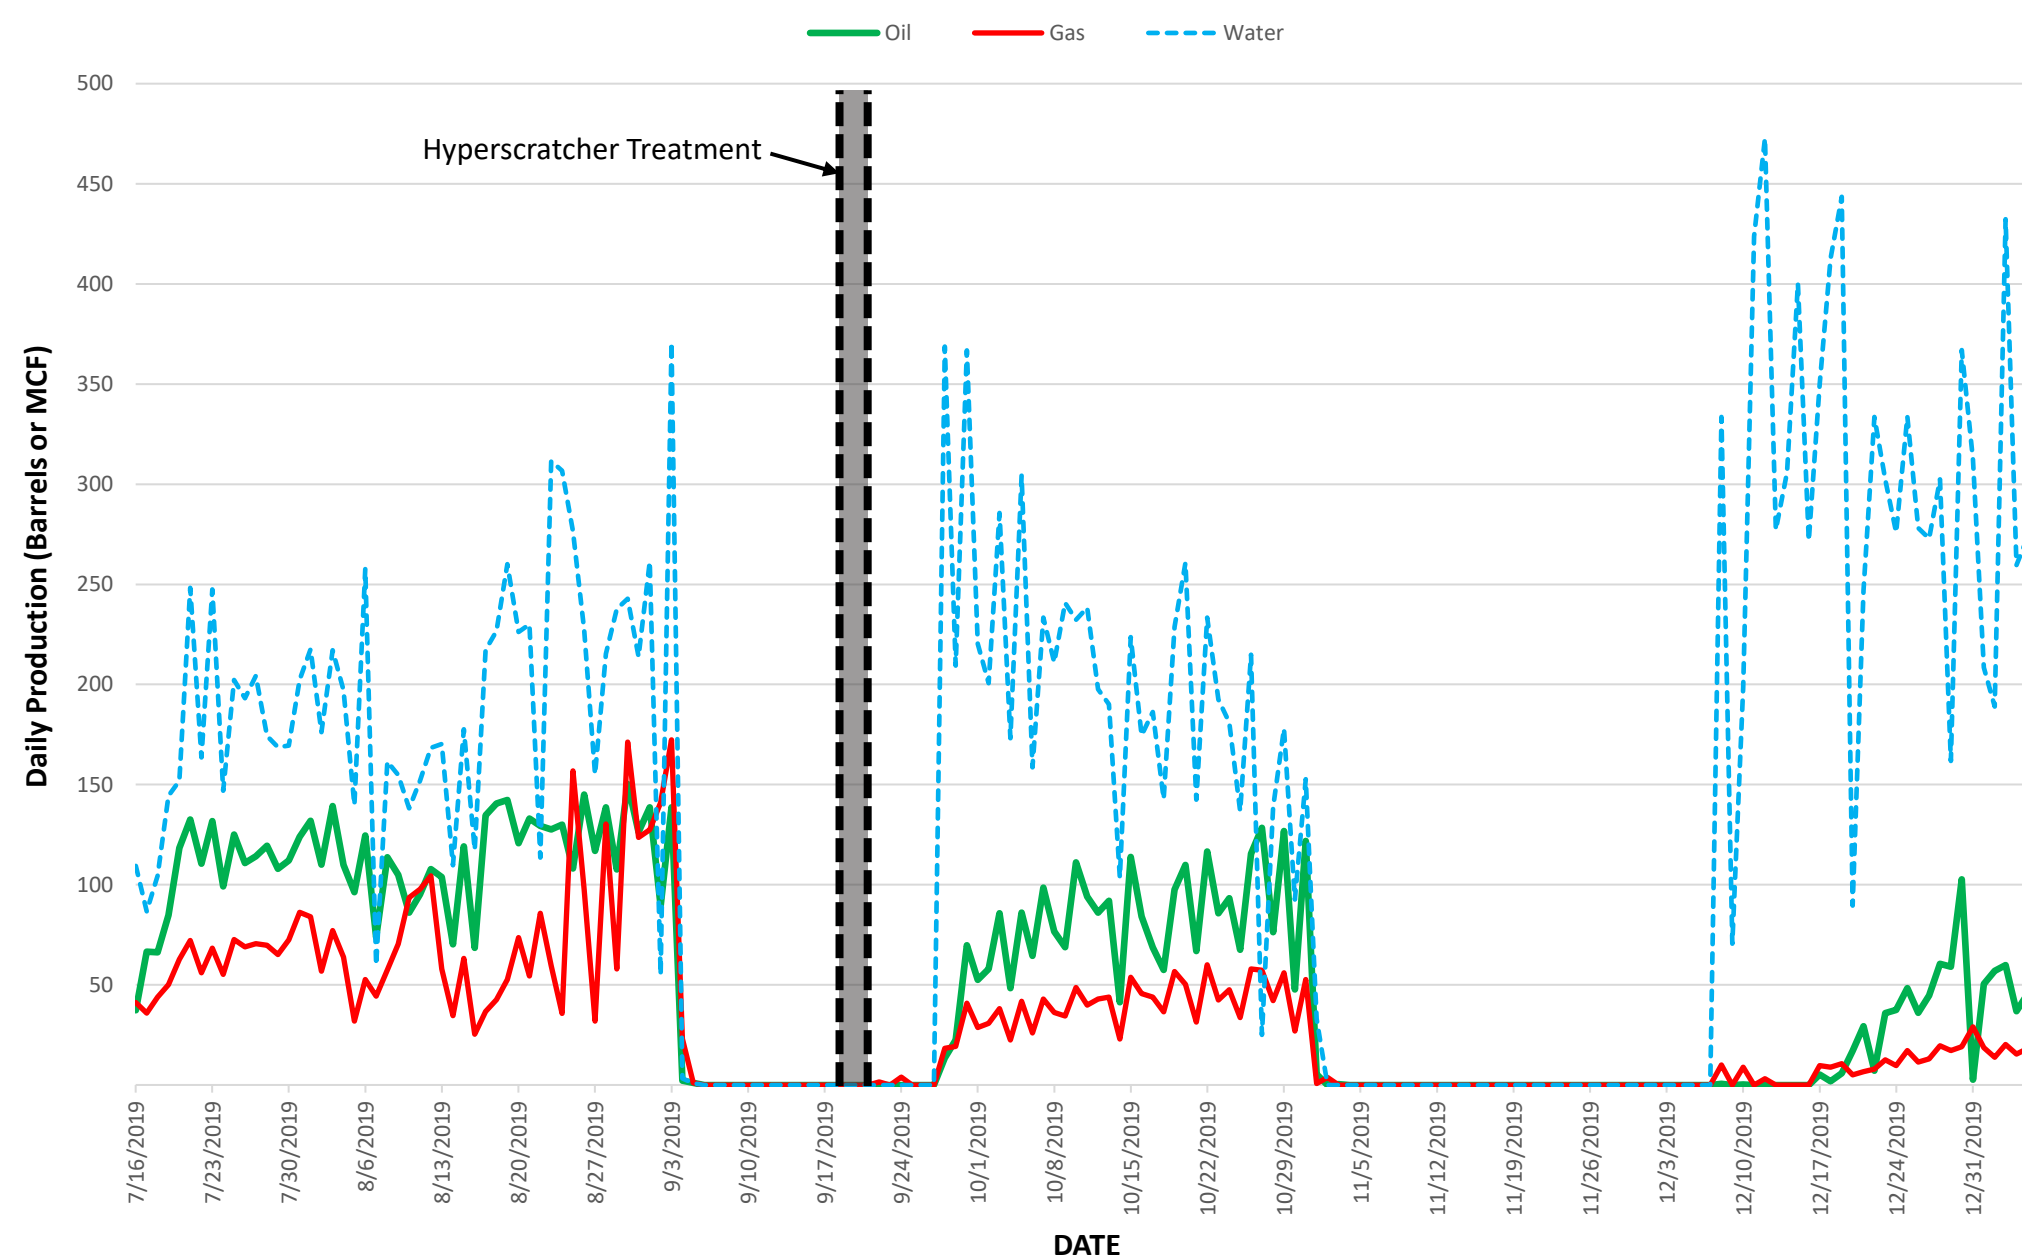
Company A "A-3 Horizontal": Daily Production

- Problem: Paraffin & Scale
- Treatment: 9/19-22/2019
- Pumped 5 bbls chem-treated water thru tool jets at each perf set
- Pumped 64 bbls acid after tool treatment
- Flushed with 150 bbls chem-treated produced water
- No improvement to oil production

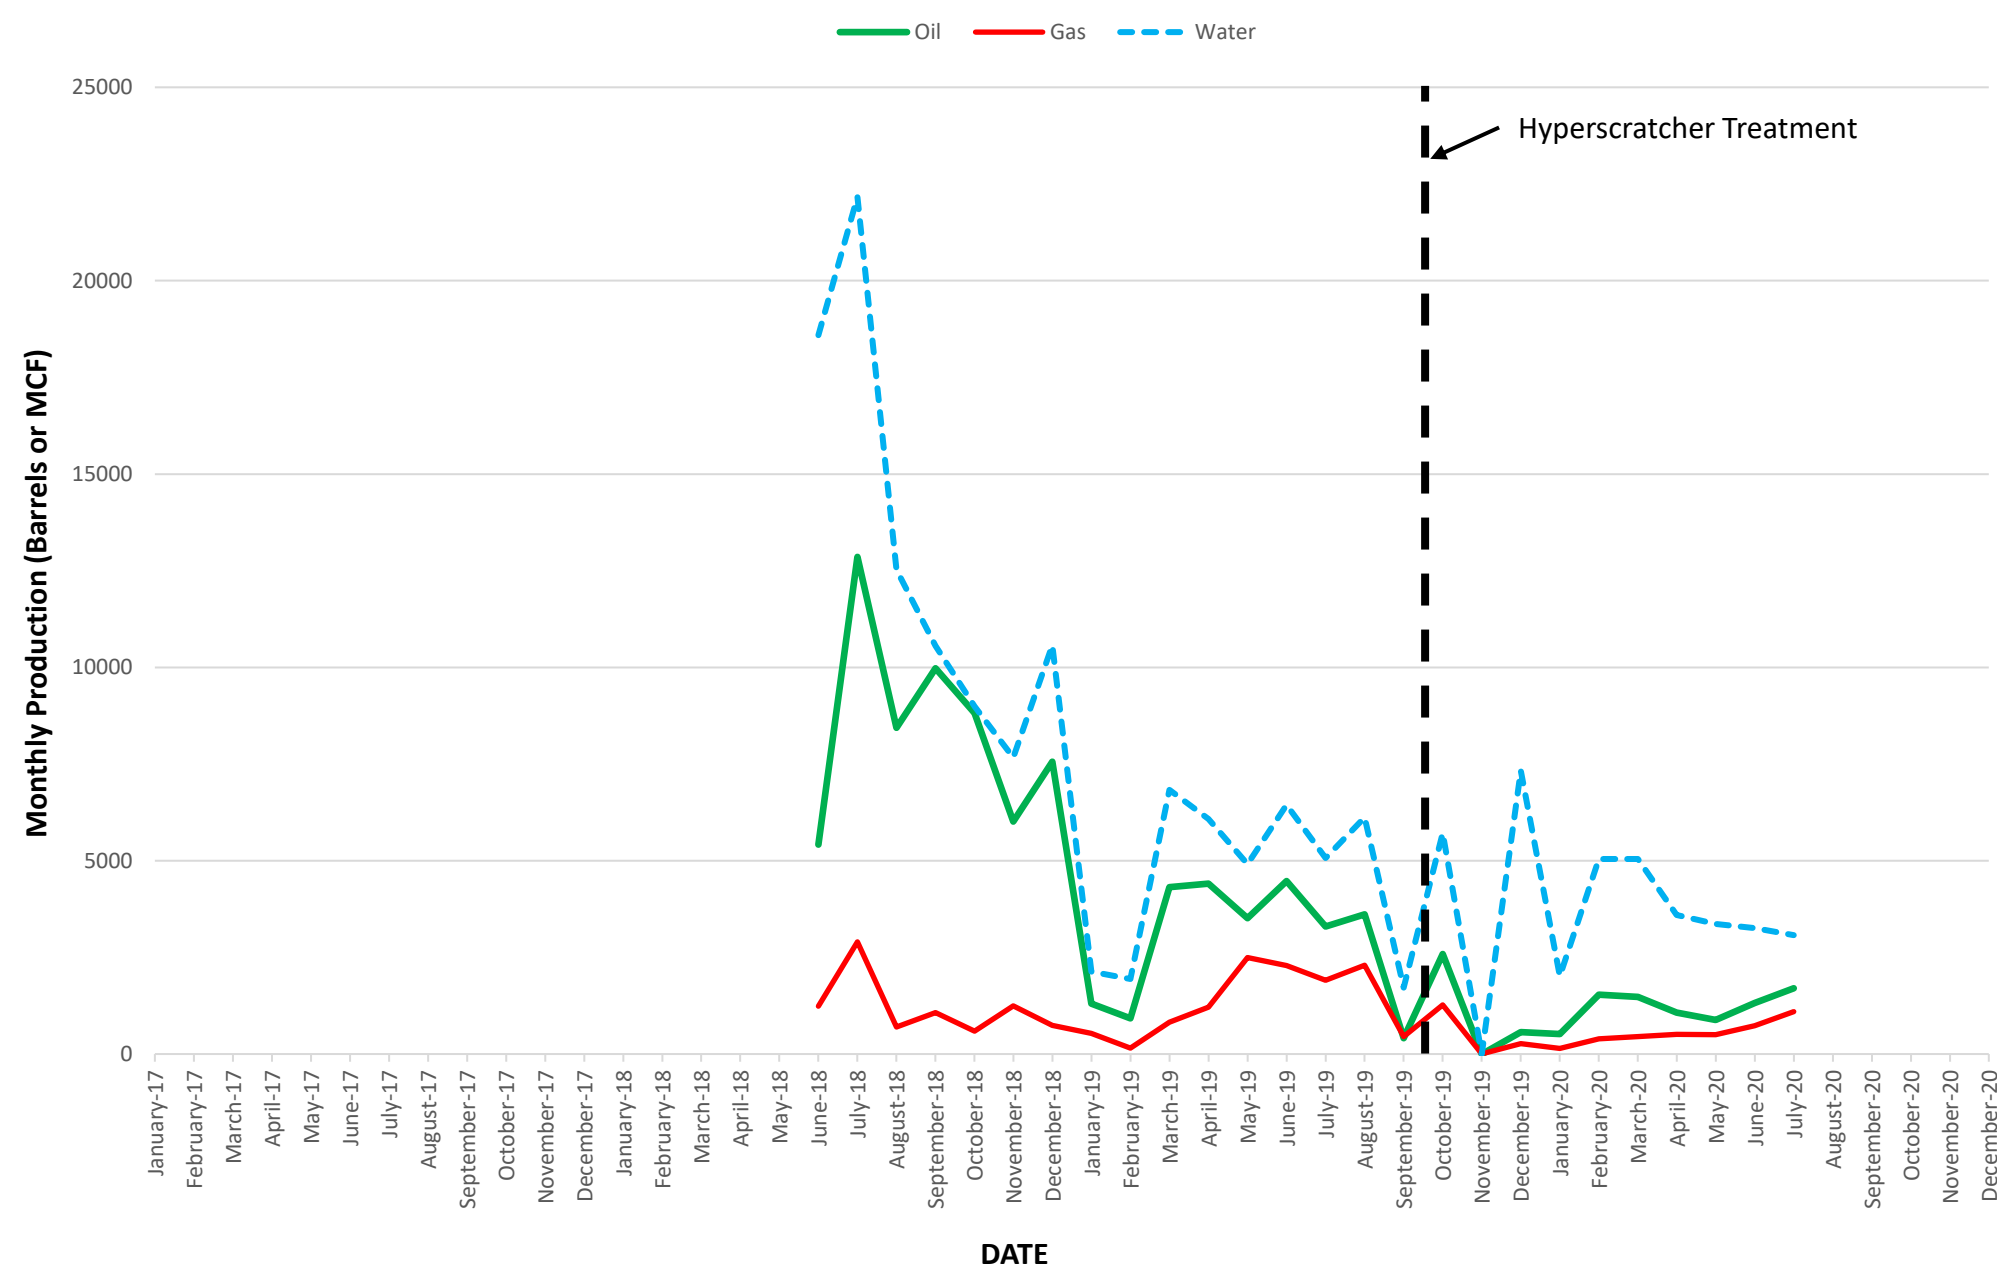
Company A "A-3 Horizontal": Monthly Production

- Problem: Paraffin & Scale
- Treatment: 9/19-22/2019
- No improvement in oil production after treatment
- Tool functioned properly (jets worked and brushes showed normal wear)
- Possible reasons for lack of improvement include:
 - Problems other than clogged perforations
 - Lack of reservoir pressure
 - Nearby horizontal wells were frac'd in November and may be interfering with this well

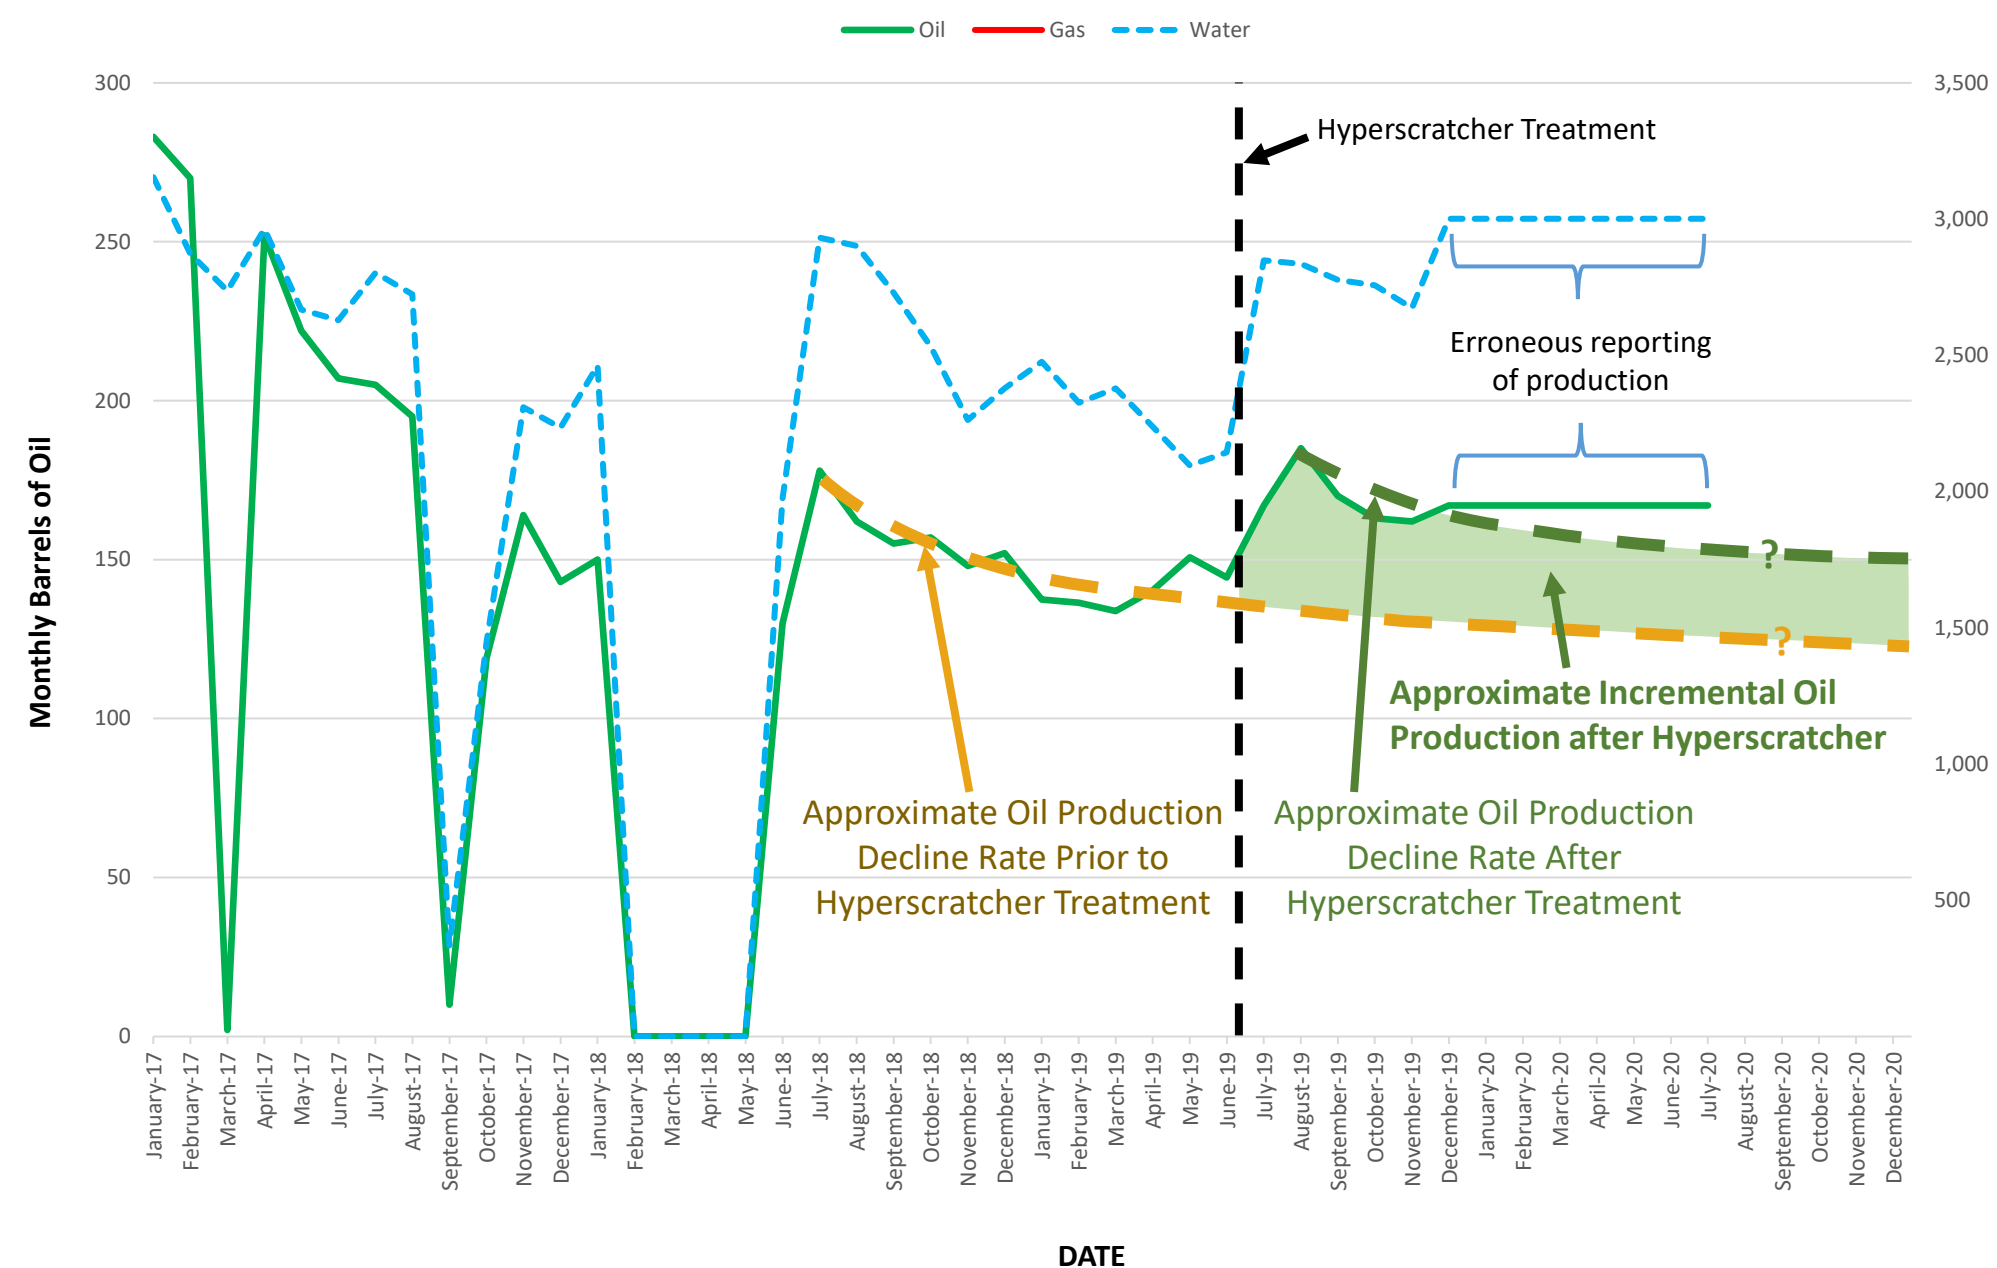
Company B "B-1" Well: Monthly Oil Production

- Problem: Paraffin
- Treatment: 6/3/2019
- Estimated Incremental recovery from 7/2019 to 7/2020 is ~400 BO
- Approximately 20% improvement in oil production over projected pre-treatment production rate
- Flat appearance to graph in 2020 production due to erroneous reporting
